Confidential Report Prepared for:
Bob and Betty Buyer:
1234 Sunshine Street
Pleasantville, ID-WA 12345

Deficient Summary

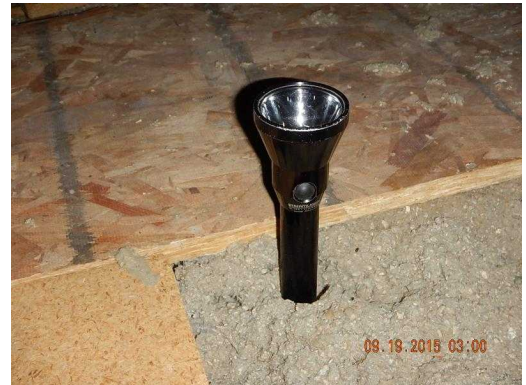
2. **Insulation Depth:** Cellulose, Blown-in>> Flashlight shown is 13" in length.

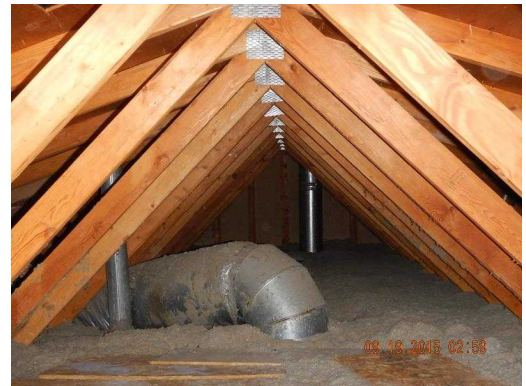
3. **Roof Framing:** 2 X Wood Truss>> The visible portions of the roof framing are in adequate condition, except as noted.

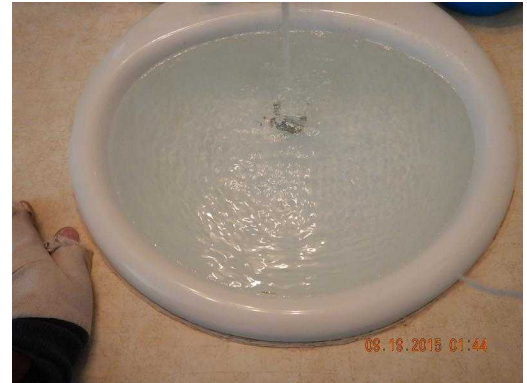
- 1. **Ceiling:** SHEET ROCK
- 2. **Counter/Cabinet:** Laminate and wood
- 3. **Floor:** Vinyl floor covering
- 4. **Doors:**
- 5. **Windows:** Double Pane
- 6. **Outlets:** 110 VAC GFCI
- 7. **Faucets/Traps:** Delta fixtures with a PVC trap
- 8. **Sink/Basin:** PORCELIN>> The overflow drain is plugged and caution should be used when filling basin

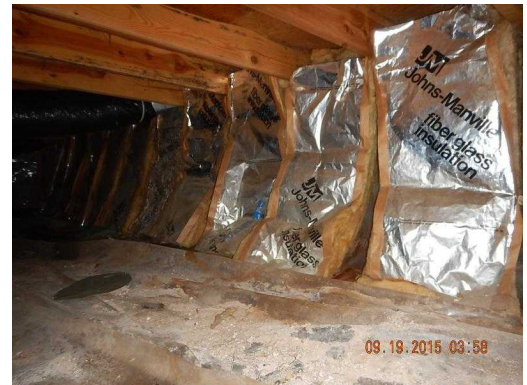
- 1. Method of Inspection: ENTERED CRAWL SPACE
- 2. Access/Location: Master Bedroom, Closet Floor
- 3. Electrical: 120 VAC
- 4. Framing: 2 X I-Joists
- 5. Insulation: Rolled Fiberglass at Perimeter Walls

- 6. Moisture Penetration: No moisture present at time of inspection
- 7. Vapor Barrier: Visqueen>> The soil is covered with a vapor barrier, (plastic sheeting), in order to reduce ambient humidity in the crawlspace. This is beneficial and is required in most jurisdictions.

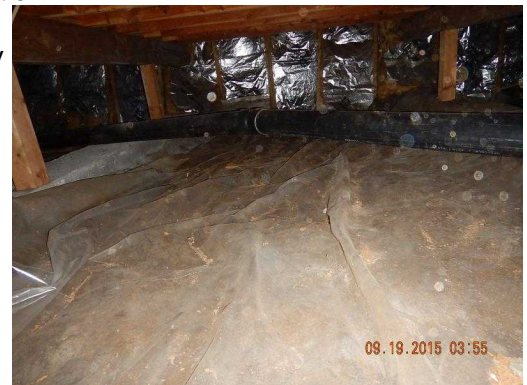
- 8. Ventilation: PERIMETER VENTS>> We observed that a number of the crawlspace vents are closed. Closed vents can promotes condensation which can promote mold conditions. Close in winter, and open in the summer.

5. **Crawl Space Ventilation:** PERIMETER VENTS>> We observed that a number of the crawlspace vents are closed. Closed vents can promotes condensation which can promote mold conditions. Close in winter, and open in the summer.

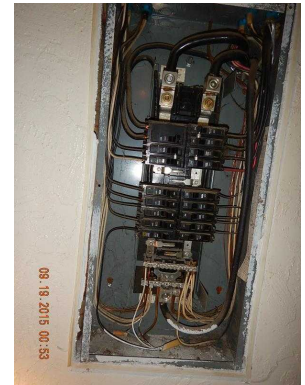
- 6. **Power Panel Observations:** CUTLER HAMMER>> Power panel and its components have no visible deficiencies.

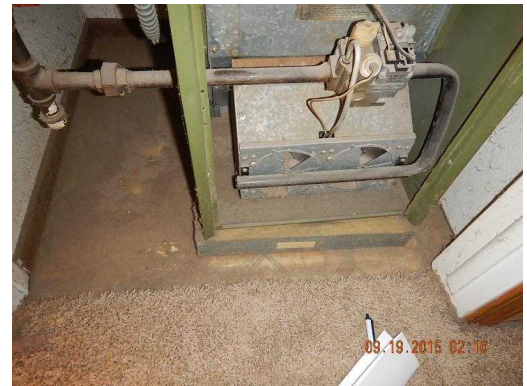
- 1. **Heating System Observations:** Responded to Normal User Controls
- 2. **Manufacturer:** CARRIER:
- 3. **Type:** FORCED AIR **Capacity:** 100K BTUs
- 4. **Area Served:** Whole house **Approximate Age:** 2004, Per Data Plate
- 5. **Fuel Type:** Natural Gas
- 6. **Blower Box::** LOWER UNIT>> The filter, blower box and area is dirty, recommend cleaning.

6. **Heating System Blower Box::** LOWER UNIT>> The filter, blower box and area is dirty, recommend cleaning.

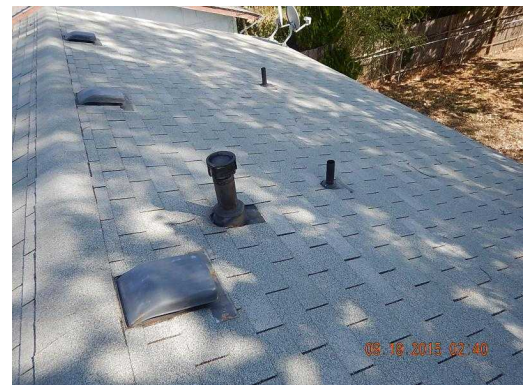
- 1. **Method of Inspection:** WALKED on ROOF
- 2. **Material:** ASPHALT COMPOSITION SHINGLES>> The visible portions of the surface granulation had washed away. These are normal signs of aging and no action is needed at this time, except as noted elsewhere in this report. Regular monitoring and routine maintenance recommended on a biannual schedule.

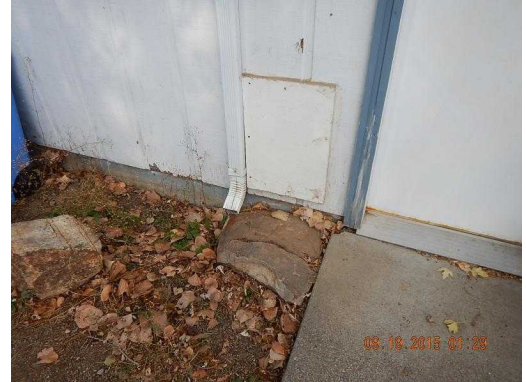
- 6. **Leader/Extension:** Extend runoff drains to move water away from foundation for improved site drainage and foundation integrity

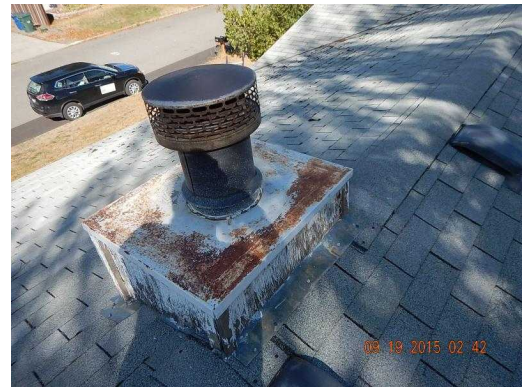
- 8. **Chimney:** Metal pipe, Framed>> The composite wood siding has deteriorated. Recommend correcting.

9. **Chimney Chimney:** Metal pipe, Framed>> The composite wood siding has deteriorated. Recommend correcting.
